Water Damage Investigation

**McAvinnue Elementary School
131 Mammoth Road
Lowell, Massachusetts**

Prepared by:
Massachusetts Department of Public Health
Bureau of Environmental Health
Indoor Air Quality Program
August 2018

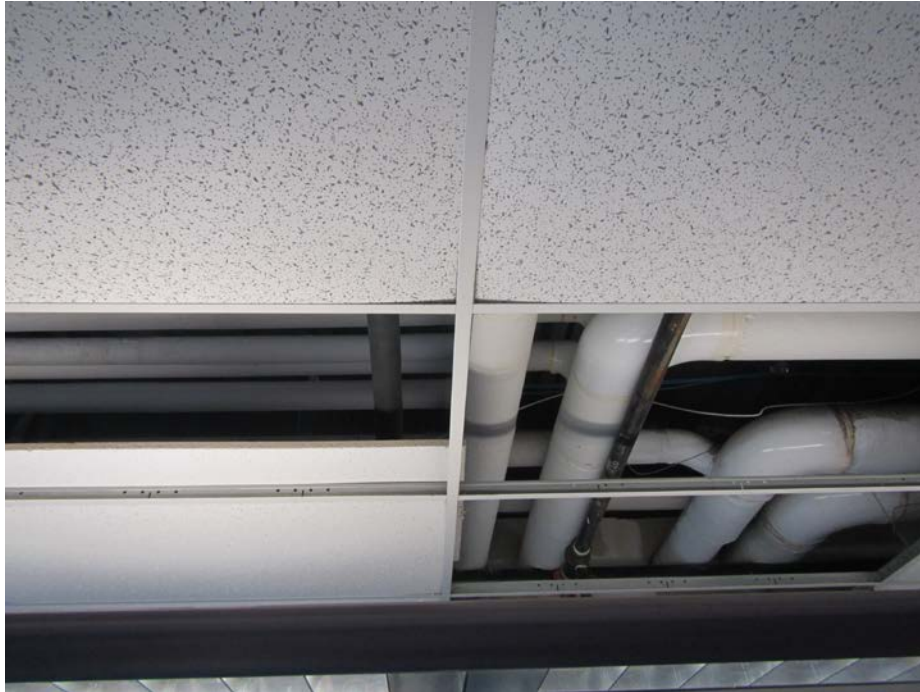
Picture 1

- ***Classroom 109:*** MES facilities personnel reported that numerous ceiling tiles had become mold-colonized. In addition, dust/debris on surfaces (e.g., desks) were colonized with mold in some areas of this room. During this assessment, all but one of the affected ceiling tiles had already been discarded but new tiles were not yet in place (Picture 1 and 2). In addition, it was reported that the room had been fogged with an antimicrobial product and all surfaces cleaned twice thoroughly. The carpet was clean and dry and no musty odors were detected. However, there appeared to be some spots of colonization on the rigid pipe insulation above the ceiling tile system in one area, likely on dust/debris on the insulation (Picture 3). The MES was reported to utilize *ducted* return lines rather than a ceiling plenum return system which will greatly reduce the risk of entrainment into the HVAC system (Picture 4).

Most water-damaged or mold-colonized ceiling tiles were removed prior to this assessment

5. Replace all water-damaged/missing ceiling tiles.
6. Consider using dehumidifiers in areas prone to excessive moisture/condensation especially during forecasted extended high humidity weather events.

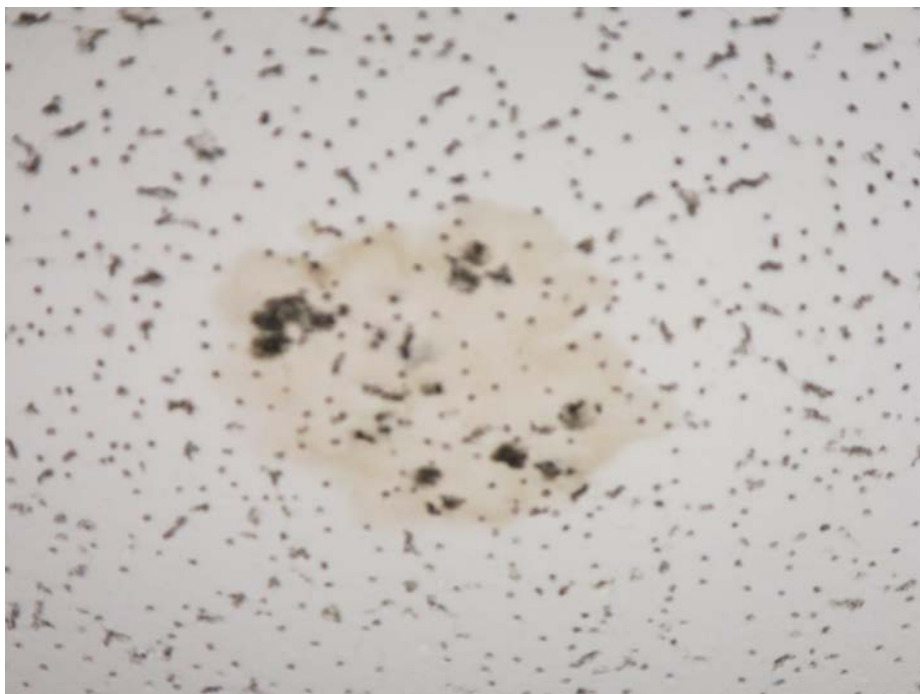
Picture 2

Single remaining water-damaged ceiling tile remaining above light fixture in classroom 109 (to be removed)

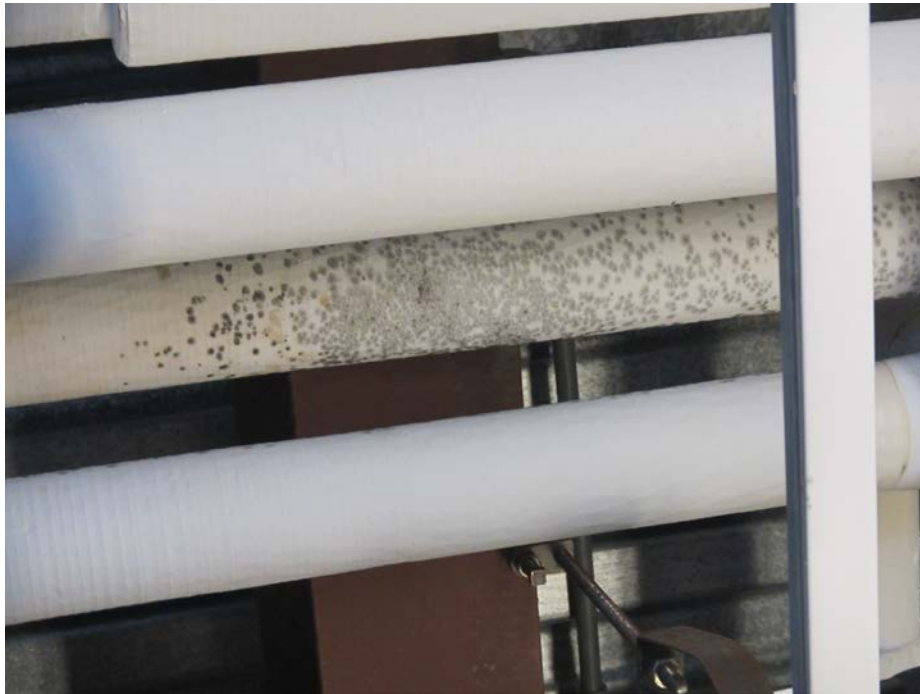
Picture 3

Spots of mold-colonization on outside of cooling line insulation

1. Continue to discard any remaining porous items if found to be colonized with mold (e.g., ceiling tiles, seat cushions, area rugs, cardboard) or water-damaged.
2. Inspect the water-damaged cooling line insulation closely. If colonization appears to be on the surface (in dust/debris) then these areas may be cleaned with mild detergent. If the colonization has penetrated the nonporous coating and entered into the fabric wrapping or insulation, then the insulation would need to be cut out, discarded and replaced with new insulation

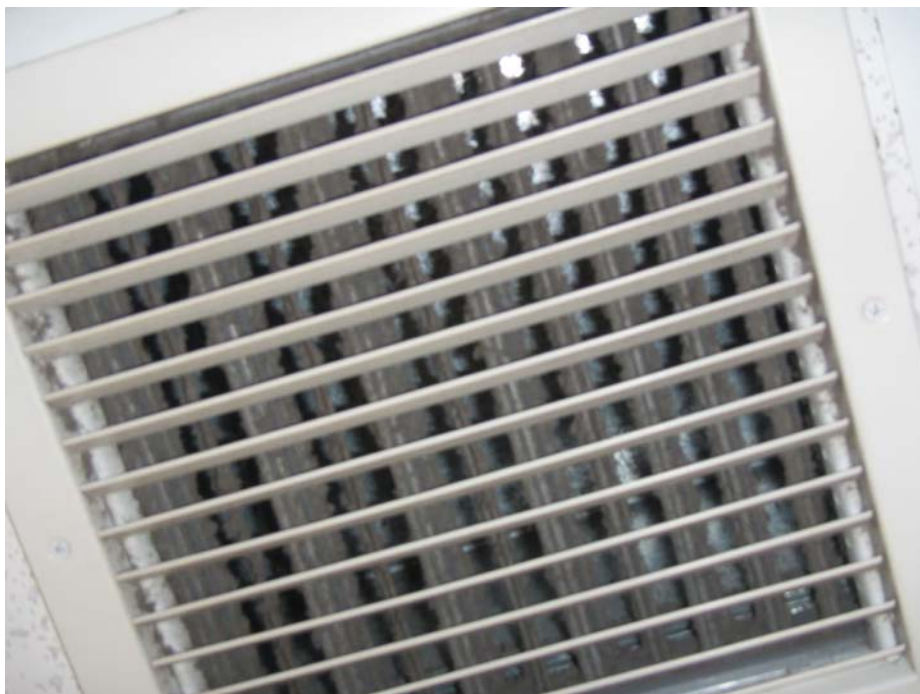
Picture 4

Ducted return line in classroom 109 (note dust on vent)

3. Perform any work during unoccupied hours and thoroughly clean the area and surfaces after work is complete.
4. Clean supply and exhaust/return vents of accumulated debris regularly.

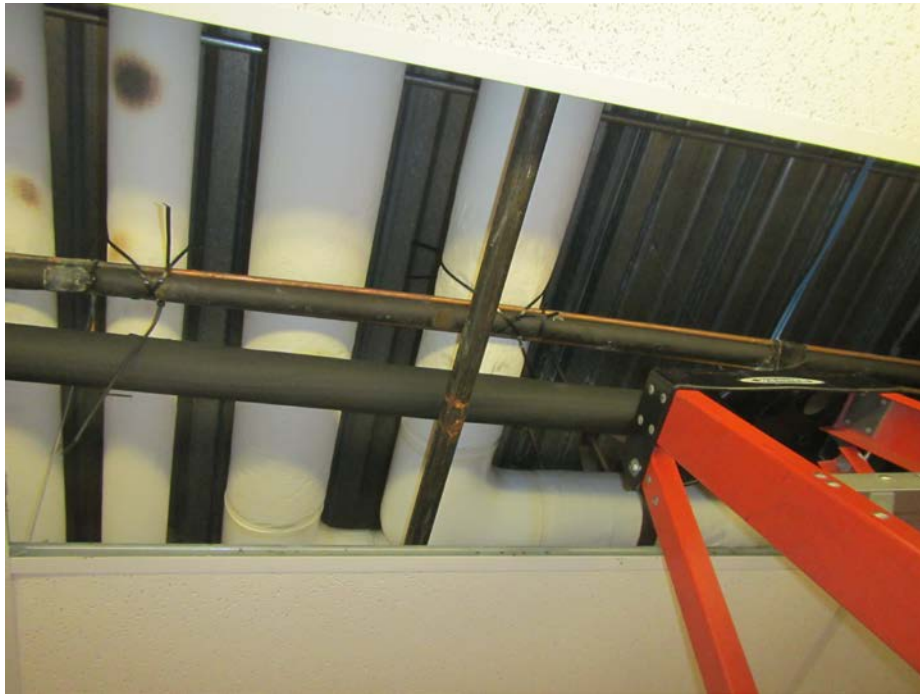
Picture 5

- ***Classroom 210:*** This room was reported to have had several water-damaged ceiling tiles due to insufficient insulation of the HVAC cooling lines above. Since the temperature of the cooling lines was likely well below the dew point temperature, condensation was responsible for this water damage. These tiles had already been discarded and contractors were finishing the new insulation of the HVAC cooling lines during the assessment (Picture 5). No other porous materials appeared to be affected by water damage. The floor and walls were nonporous and easily cleanable (e.g. tile and concrete block). MES facilities personnel stated that this room will be thoroughly cleaned following the completion of the work.

New cooling line insulation being installed in classroom 210 where condensation occurred
